Audit Report on Forest Plantations.

Agua Fría, District of Chepigana, Province of Darien,
Republic of Panama.

EcoWood
Panama Services, S.A.

November 2018

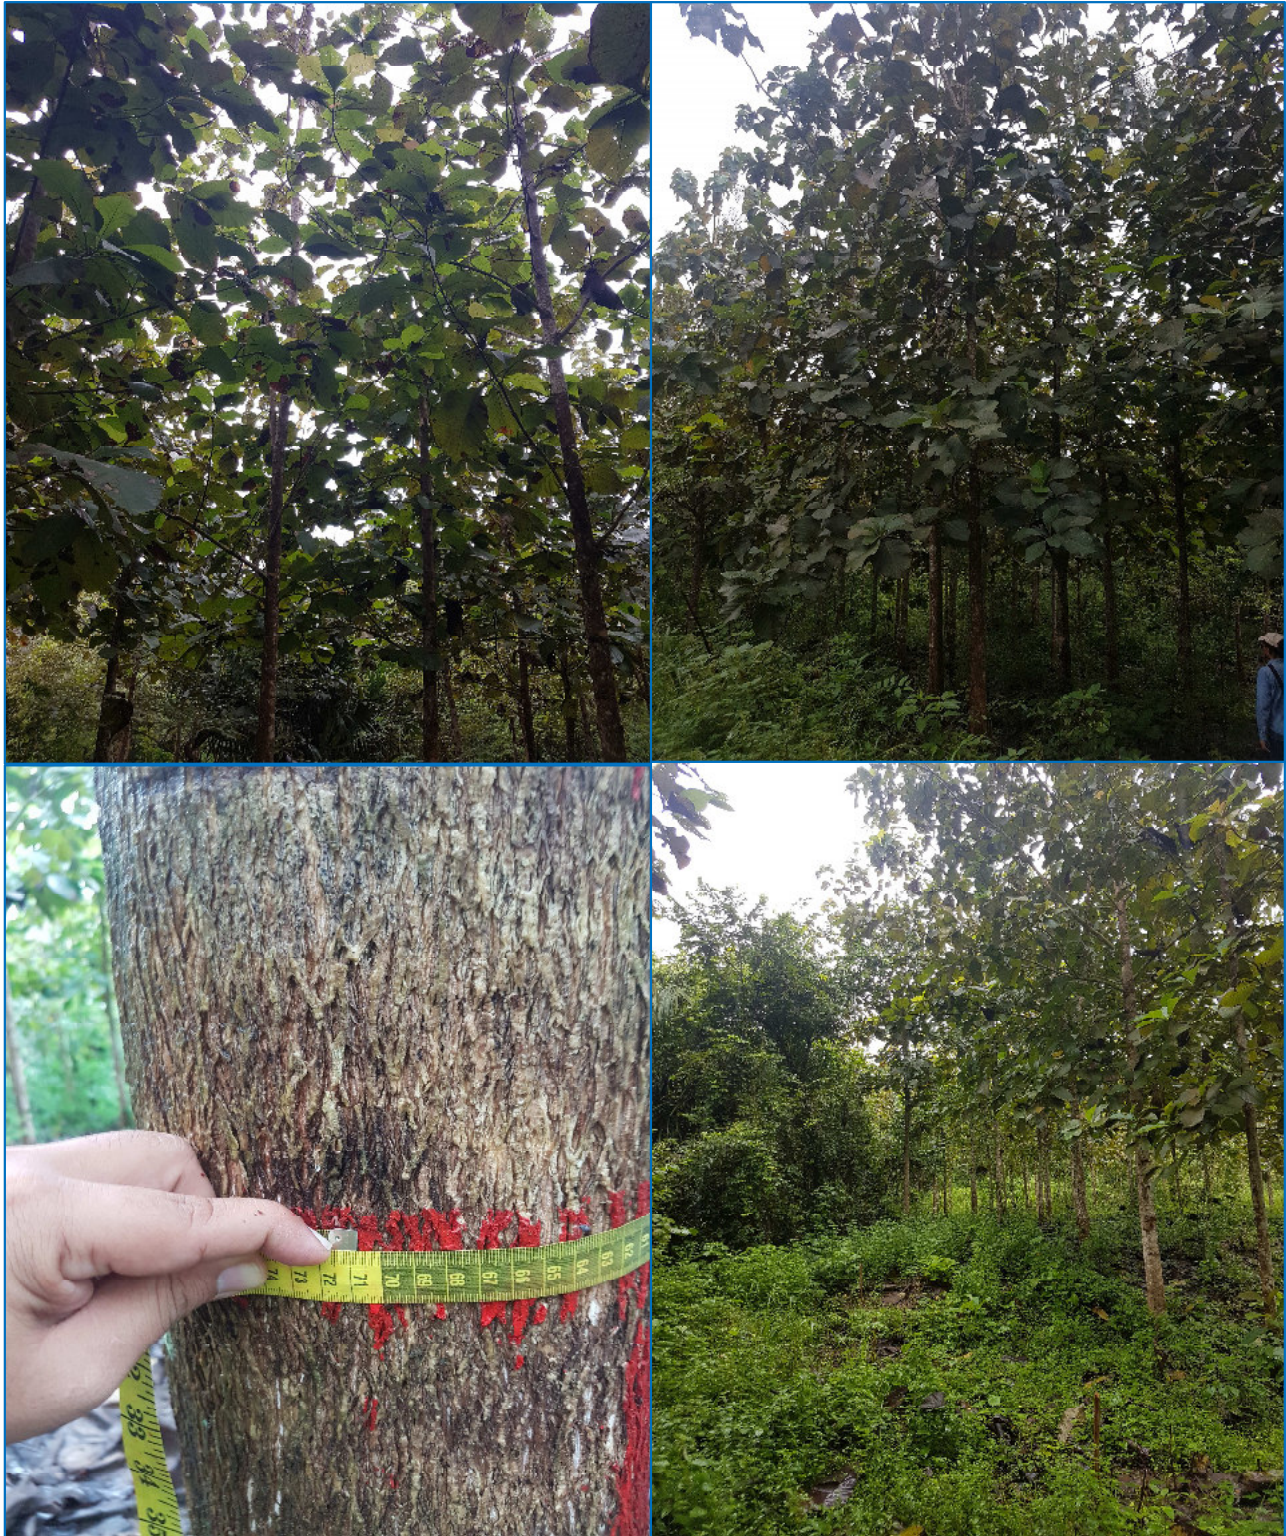
Panoramic view of commercial teak plantations - Audit Project La Reina - November 2018

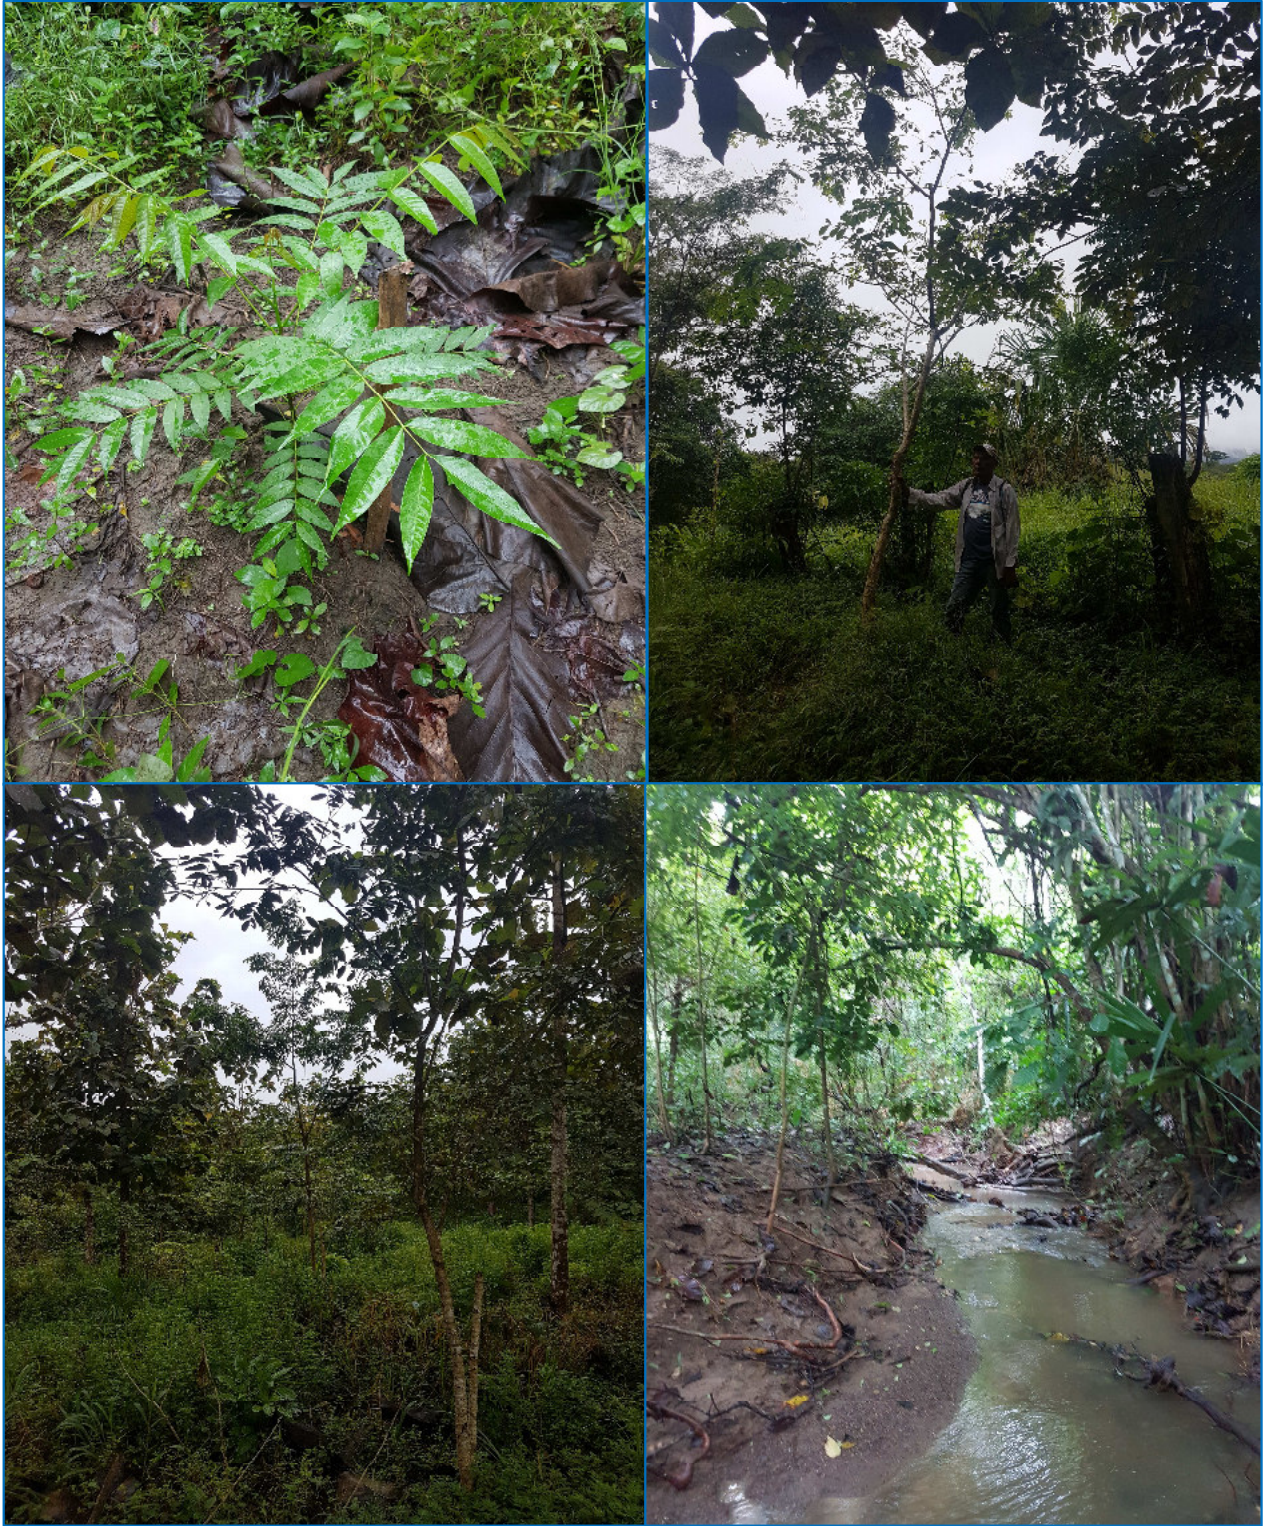
View of native species and conservation areas - Audit La Reina November 2018
